**MARYLAND HISTORICAL TRUST
DETERMINATION OF ELIGIBILITY FORM**

Property Name: Quarles Property Inventory Number: CH-814
Address: 10300 Rosewick Road City: La Plata Zip Code: 20646
County: Charles USGS Topographic Map: La Plata
Owner: Mary Alice Quarles Is the property being evaluated a district? ☐ yes
Tax Parcel Number: 314 Tax Map Number: 23 Tax Account ID Number: 048609
Project: St. Charles Parkway Extension Agency: _____
Site visit by MHT Staff: ☒ no ☐ yes Name: _____ Date: _____
Is the property located within a historic district? ☐ yes ☐ no

Continuation Sheet No. 1

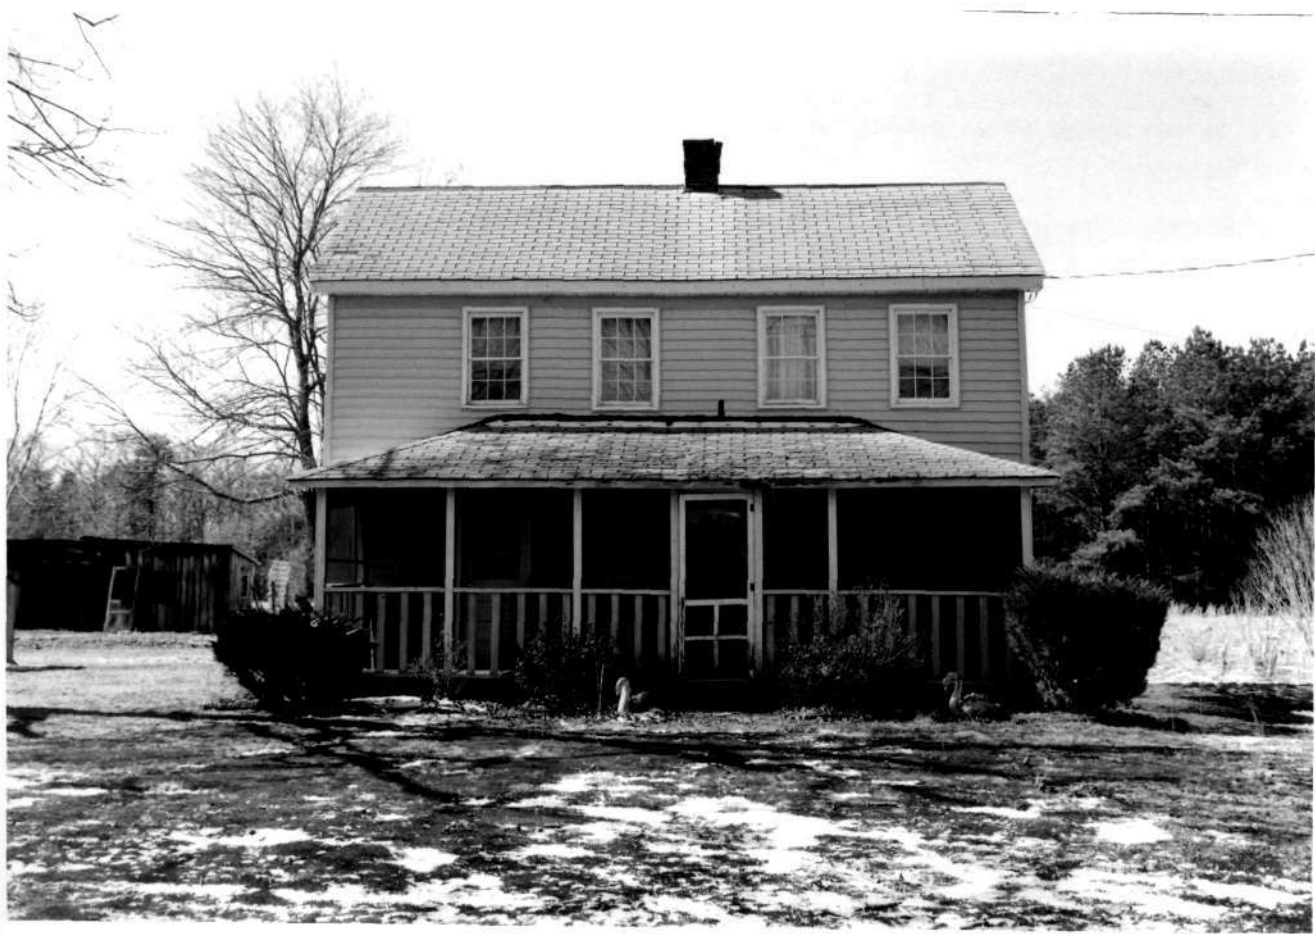
2 OF 10

The driveway provides access to the dwelling and the tobacco barn. The early-twentieth century dwelling faces east. The four-bay-by-one-bay rectangular dwelling rises two stories. The wood-frame dwelling terminates in a gable roof sheathed in asphalt shingles. A central brick chimney pierces the roof. The building is clad in vinyl siding. Windows consist of six-over-six, double-hung, wood-sash units and vinyl replacement units. A full-width porch extends along the east elevation. An addition was constructed on the rear (west) elevation.

The four-bay east (front) elevation is spanned by a hipped roof, screened porch. Simple, square wood columns support the porch roof. The porch roof is sheathed in asphalt shingles. Wood balusters and a wood balustrade provide the building's only

ornamentation. Two doors provide access to the dwelling. A three-panel, three-light, wood door is located in the south bay of the east elevation. North of this door is a two-panel, three-light, wood door flanked by windows. First floor windows are two, six-over-six-light, double-hung, wood-sash units. All windows on the second floor consist of six-over-six-light, double-hung, vinyl-sash replacement units, with applied muntins. No windows are present on the north elevation. Windows are located on the first floor of the south elevation and consist of paired, four-over-four-light, double-hung, vinyl replacement sash units, with applied muntins. Two, six-over-six-light, double-hung, wood-sash windows are found at the second floor of the west elevation.

DWELLING, E. ELEN

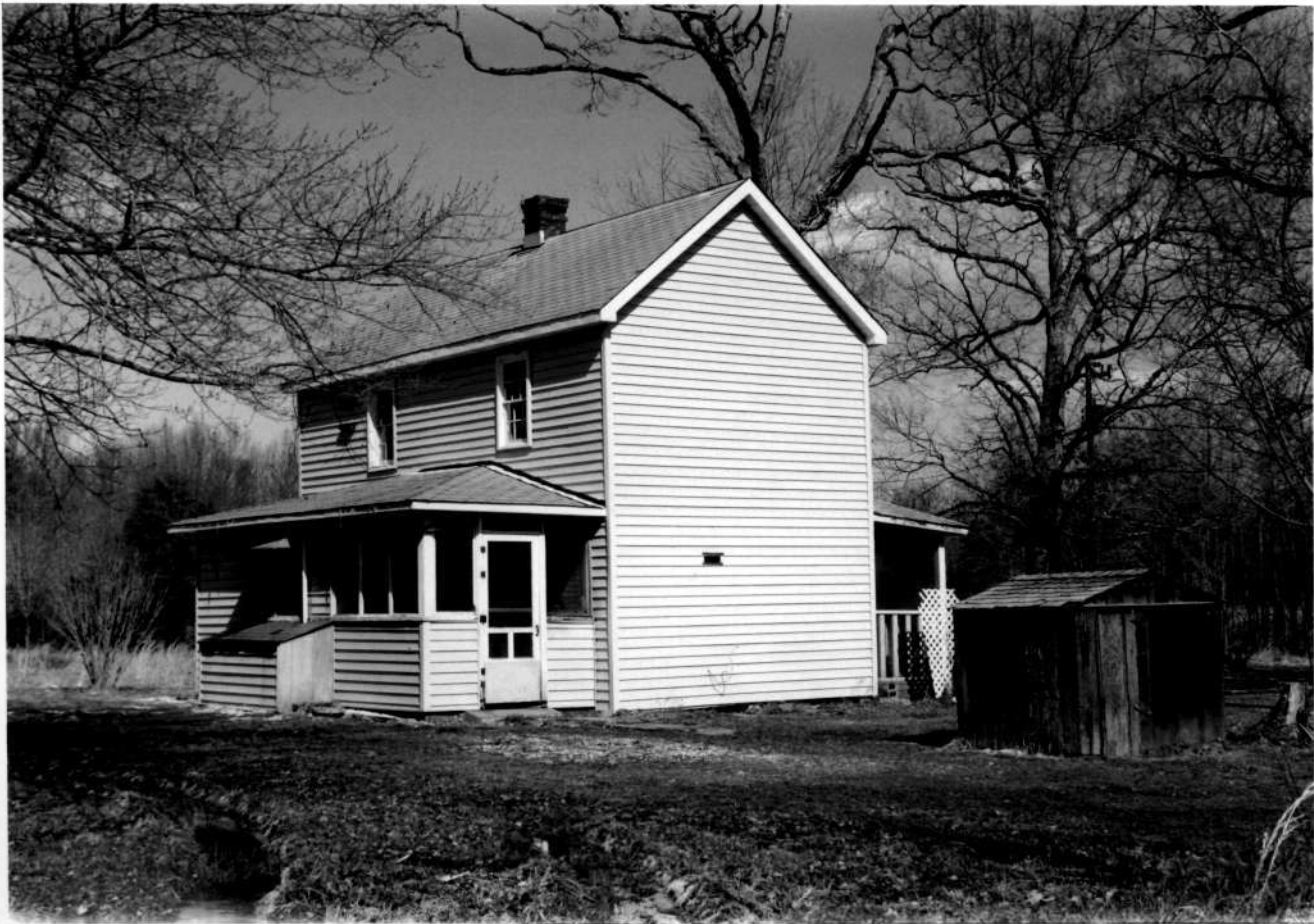
3 OF 10

The rear (west) elevation is defined by a one-story, hipped roof addition. The wood-frame addition rests on a concrete block foundation. The frame addition is clad in vinyl siding. The south elevation and part of the addition's west elevation are partially screened to create a porch. A wood, screened door provides access to the addition from the south. A six-over-six-light, double-hung, vinyl-sash window, with vinyl applied muntins is centered in the addition. A metal awning is located above the window. A vinyl-sided, shed roof enclosure is found underneath the first floor window.

DWELLING, SW ELEV

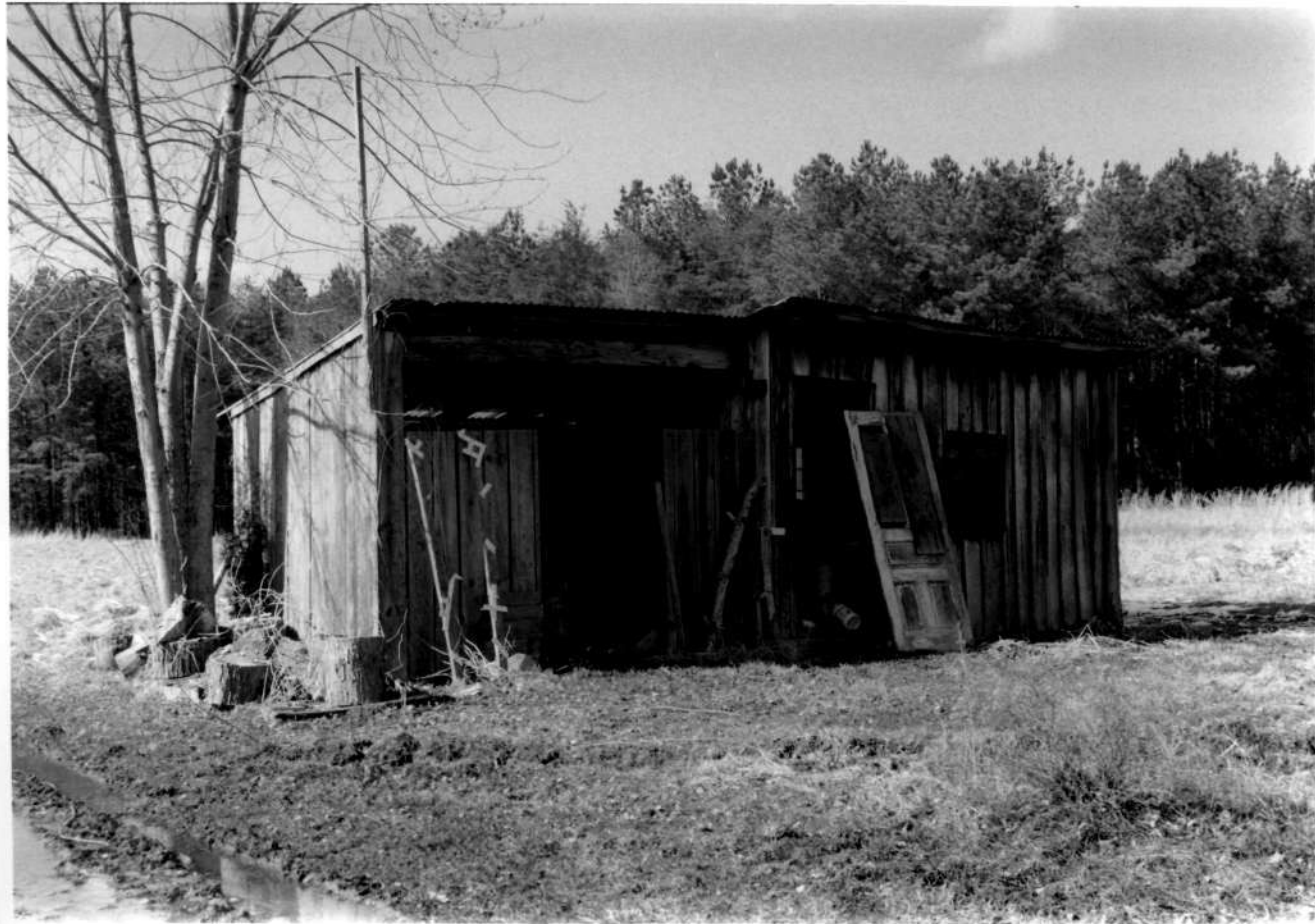
4 OF 10

A mid-twentieth century storage building/animal shelter is located southwest of the dwelling. The wood-frame building faces east. The rectangular building terminates in a shed roof sheathed in corrugated metal. The storage portion of the building rests on wood sills; the animal shelter portion of the building is post-in-ground construction. The building is clad in board-and-batten siding and eight-inch vertical wood boards. The east elevation of the storage portion of the building has an off-center window opening that is covered in plywood. A door opening is present; a three-panel, two-light, wood door leans against the opening. A six-light, wood casement window is located on the north elevation. A window also is located on the west elevation; the sash is present but three lights are missing. The animal shelter section of the building has an opening on the east elevation. Some of the wood siding is missing. No other openings are present on this end of the building.

STORAGE BUILDING / ANIMAL SHELTER, SE ELEY

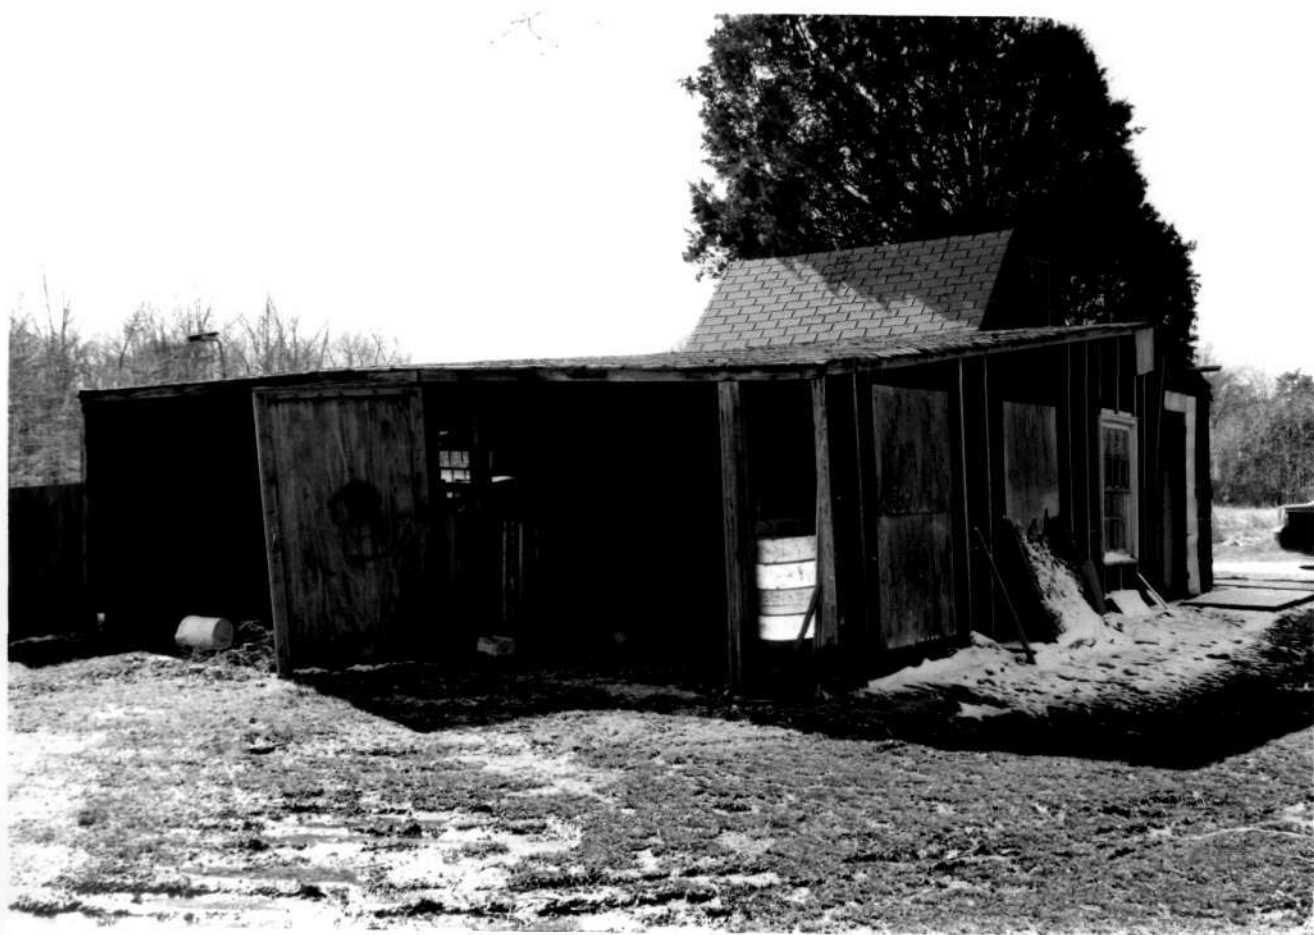
5 of 10

A mid-twentieth century garage/equipment shed is located south of the dwelling. The wood-frame building faces east. The building occupies a rectangular plan and terminates in a shed roof sheathed in asphalt shingles. The building rests on wood sills and is clad in T1-11 wood siding. Part of the siding is missing on the south elevation, exposing the tarpaper and plywood planks. The siding is completely missing on the north elevation, leaving the tarpaper exposed. On the north and east elevations, the building encompasses a formerly free-standing building. Two large openings define the east elevation. One plywood door is present. The building's three-bay south elevation features three window openings. These include an eight-over-eight-light, double-hung, wood-sash unit and a six-over-six-light, double-hung, wood-sash unit. The third window opening is covered in plywood. The north elevation also is three bays. One, eight-over-eight, double-hung, wood-sash unit is present. The remaining two openings are covered in plywood. A door opening is present in the west end of the west elevation; the door is not present. The building's interior is divided suggesting parking stalls. The west elevation is characterized by a one-story with loft building that joins the garage. The rectangular building terminates in a gable roof sheathed in corrugated metal. The building is clad in tarpaper and plywood. A one-light, fixed-sash, wood-frame window is found on the west elevation.

GARAGE, NE ELEV

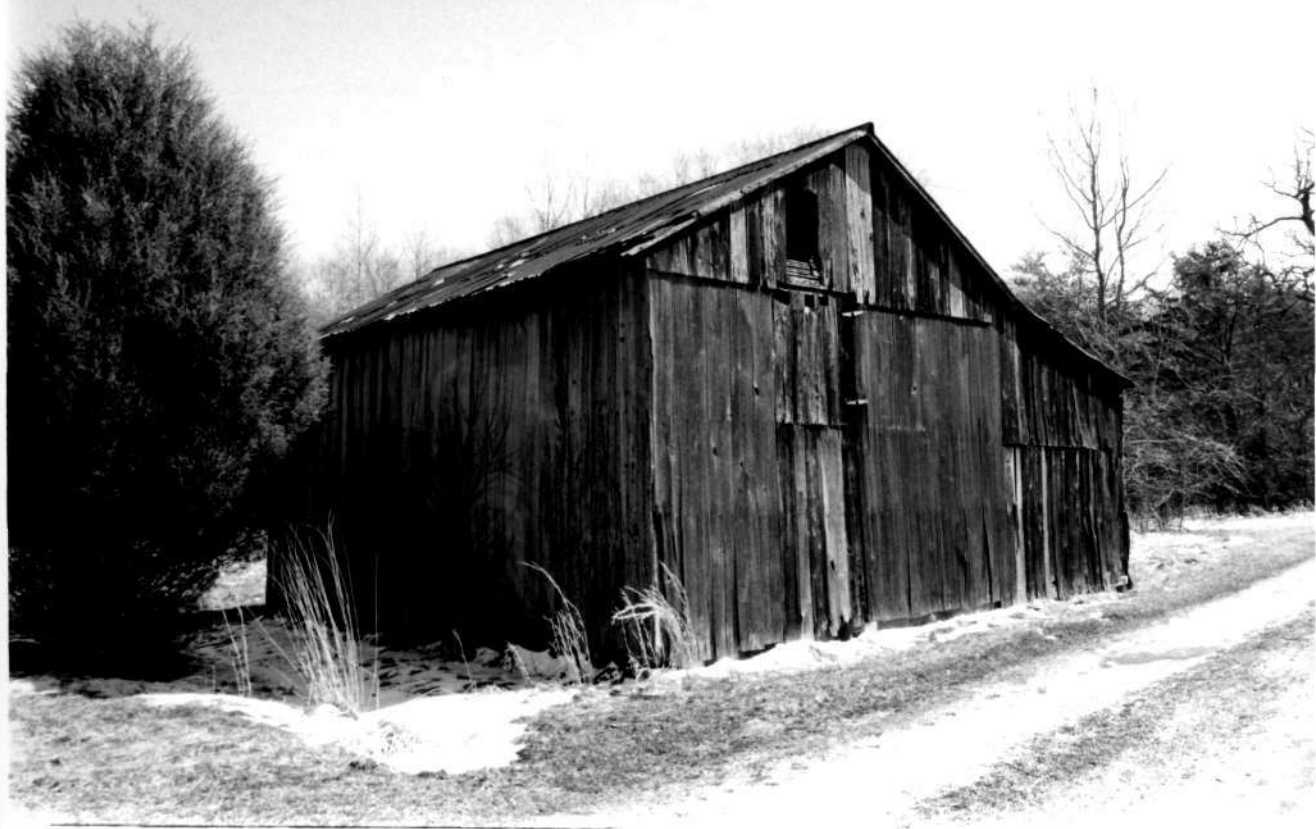
4 OF 10

An early twentieth century barn is located south of the dwelling and the garage/equipment shed. The wood-frame, one-story building with loft occupies a rectangular plan and faces east. The building rests on wood and concrete piers and terminates in a gable roof sheathed in corrugated metal. The north, east, and west elevations are clad in six-inch, vertical wood boards. The south elevation is clad primarily in corrugated metal. The building has three openings. Sliding tract, plywood doors are located on the east elevation. A door also is located in the south end of the east elevation. A hinged door is located below the loft level and above the first floor of the west elevation.

BARN 1, NW COR

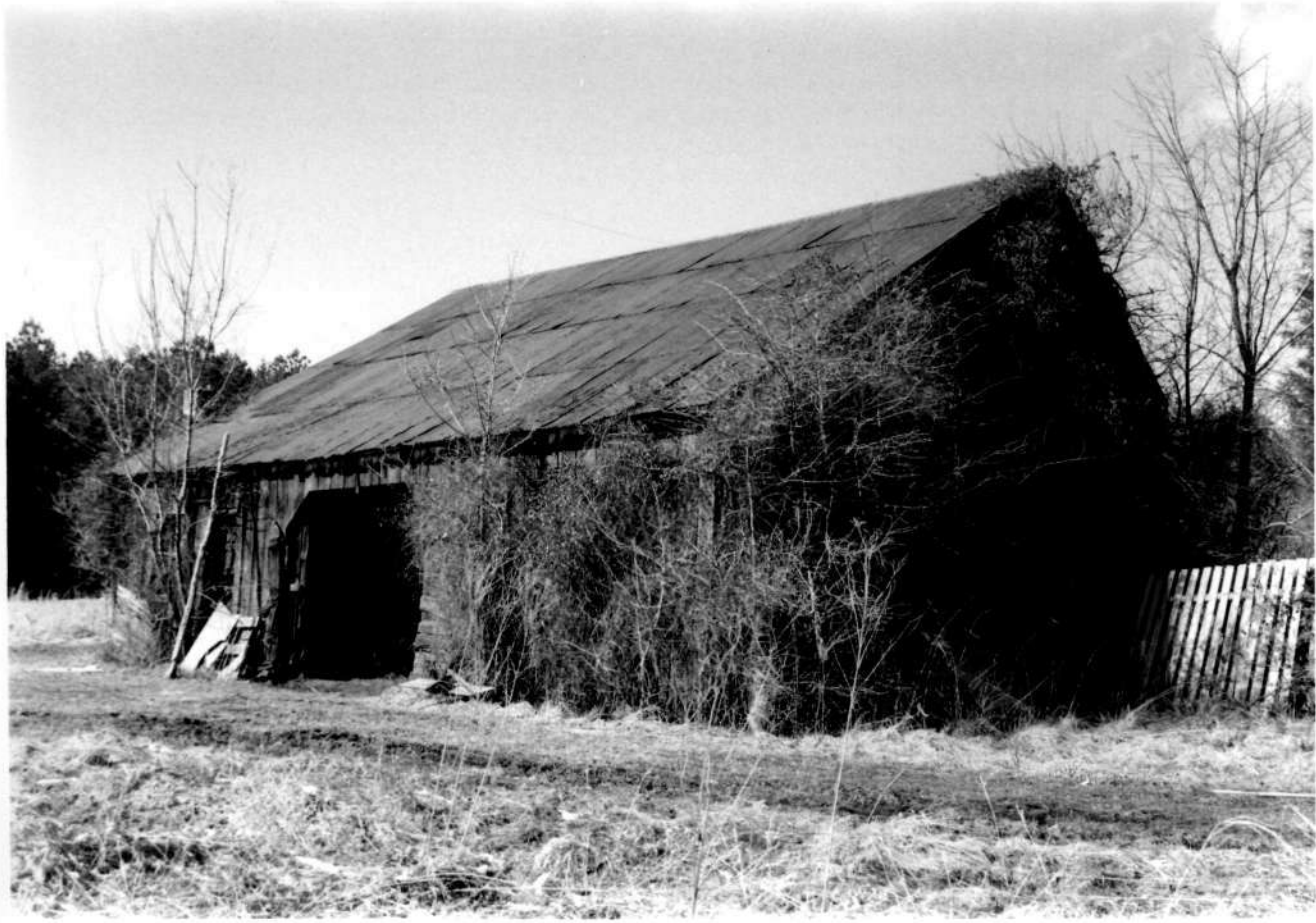
9 OF 10

An early twentieth-century, wood-frame barn is located north of the dwelling. The one-story building with loft occupies a rectangular plan and terminates in a gable roof sheathed in corrugated metal. The building is post-in-ground construction. The building is clad in vertical, wood board siding. An opening, with wood hinged doors, is located on the south elevation. A wood door also is located in the west end of the south elevation. A double-hung wood window is located adjacent to the door; all lights are missing from the window. A brick chimney is found at the south end of the west elevation. A wood-sash window

is located next to the chimney; the lights are missing from the window. Hinged, wood doors are found centered on the north elevation. A wood door is located on the south end of the east elevation. The east elevation also is partially obscured by thick, overgrown, brush. What appears to be a stripping room is located in the west end of the building. The room is elevated on concrete blocks. The rest of the building's interior is divided into stalls. The presence of what appears to be a former stripping room suggests that the building was constructed as a tobacco barn and later was converted to a barn for animals.

BARN 2, SE 22N

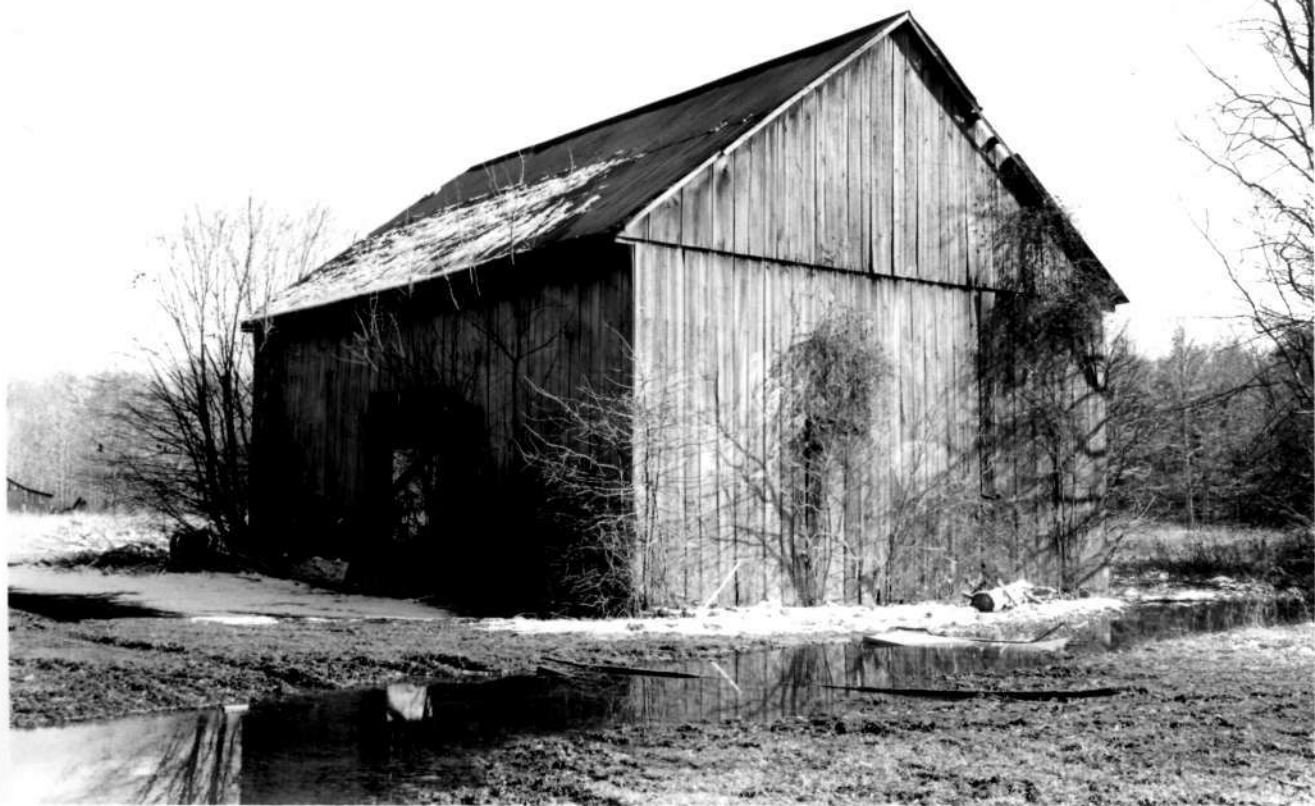
10 OF 10

An early twentieth-century tobacco barn is located west of the dwelling. The wood-frame, one story building occupies a rectangular plan and rests on concrete piers. The building terminates in a gable roof sheathed in corrugated metal. The building is clad in vertical, wood siding ranging in size between six and twelve inches. Doors are centered in the north and south elevations. The doors are missing on the north elevation; however, the hinges remain in place. A door opening also is present on the east elevation; the door is missing. Paired wood, vertical board doors are located on the west elevation. Drying racks and tobacco are present on the interior.

TOBACCO BARN, NW 21/4

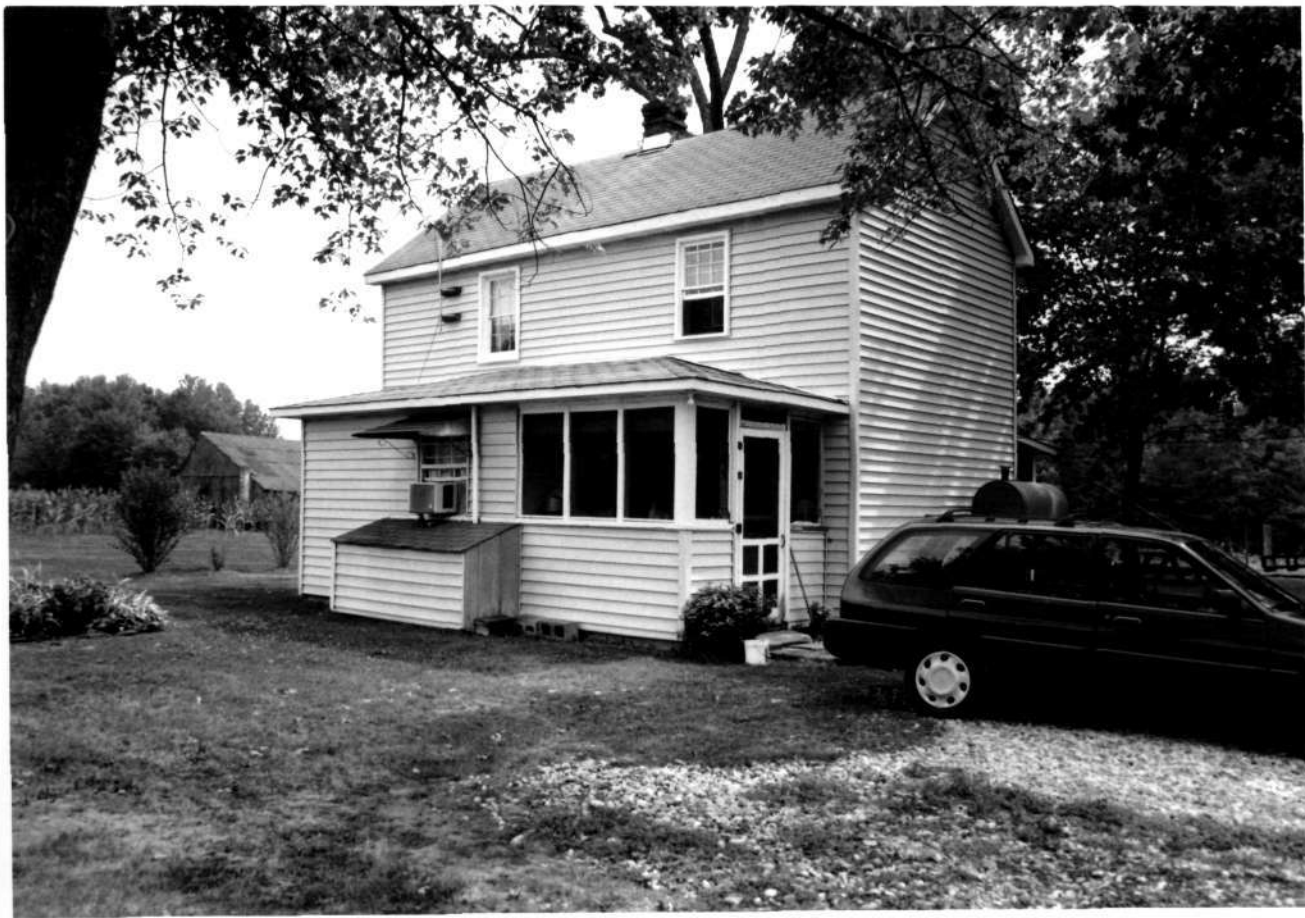
~~CH-814~~ CH-814
10300 Rosewick Road
Charles County, MD
Traceries
August, 1999
MDSHPD
View looking Northwest
1 of 2

The farm complex located at 10300 Rosewick Road comprises of a circa 1900 single family dwelling and two circa 1920 barns. The wood frame I-house is two stories in height with a side-gabled roof and a half-hipped roof projecting from the main elevation. The additional living space has been enclosed, but it could have been an open porch at one time.

The barns are located to the north of the house. One barn is one-and-one-half-stories in height and has a side gable roof. A one-story, long, shed roof extension projection to the north. The second barn is two-and-one-half stories in height and has a side gable roof. A two-story, shed roof extension projects east from the main elevation (east).

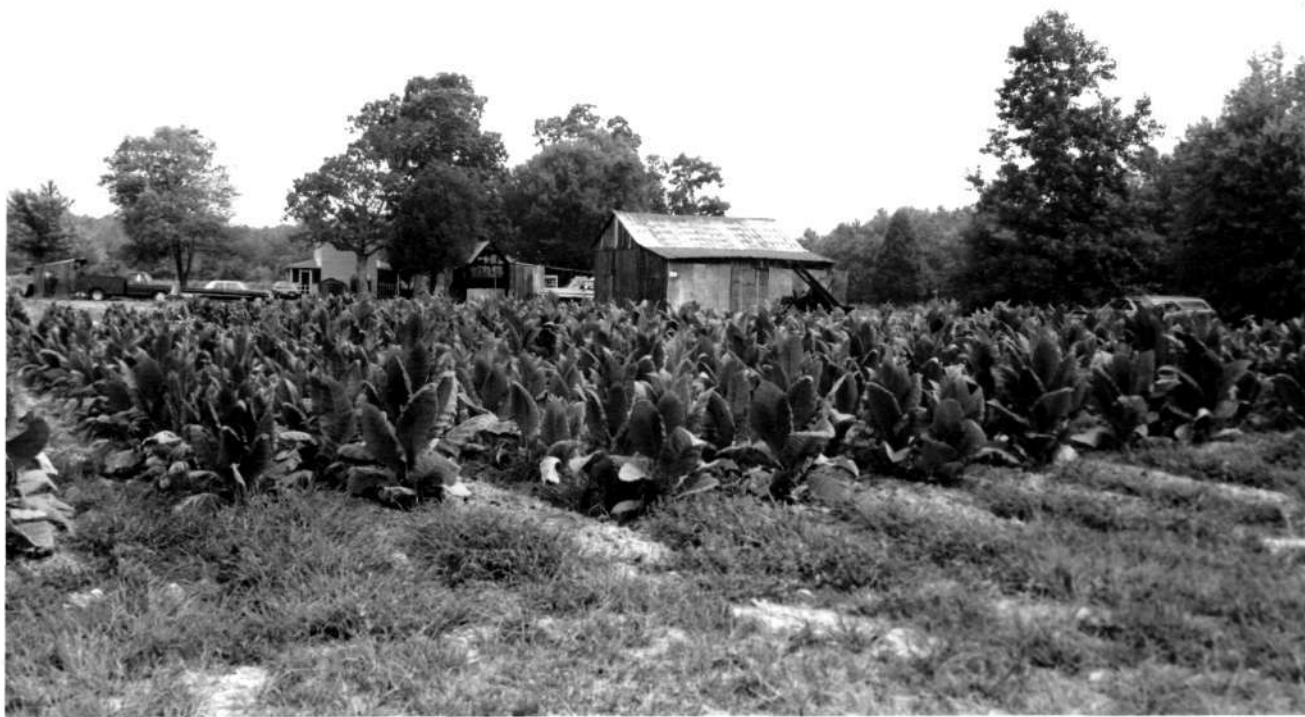
2 of 2

View looking southwest
